Project Specific Preliminary Water Quality
Management Plan, North Nance Trailer Yard,
Northwest Corner Of Webster Avenue And
Nance Street

**PROJECT SPECIFIC PRELIMINARY
WATER QUALITY MANAGEMENT PLAN
(P-WQMP)**

NORTH NANCE TRAILER YARD

NORTHWEST CORNER OF WEBSTER AVENUE AND NANCE STREET
PERRIS, CALIFORNIA 92571

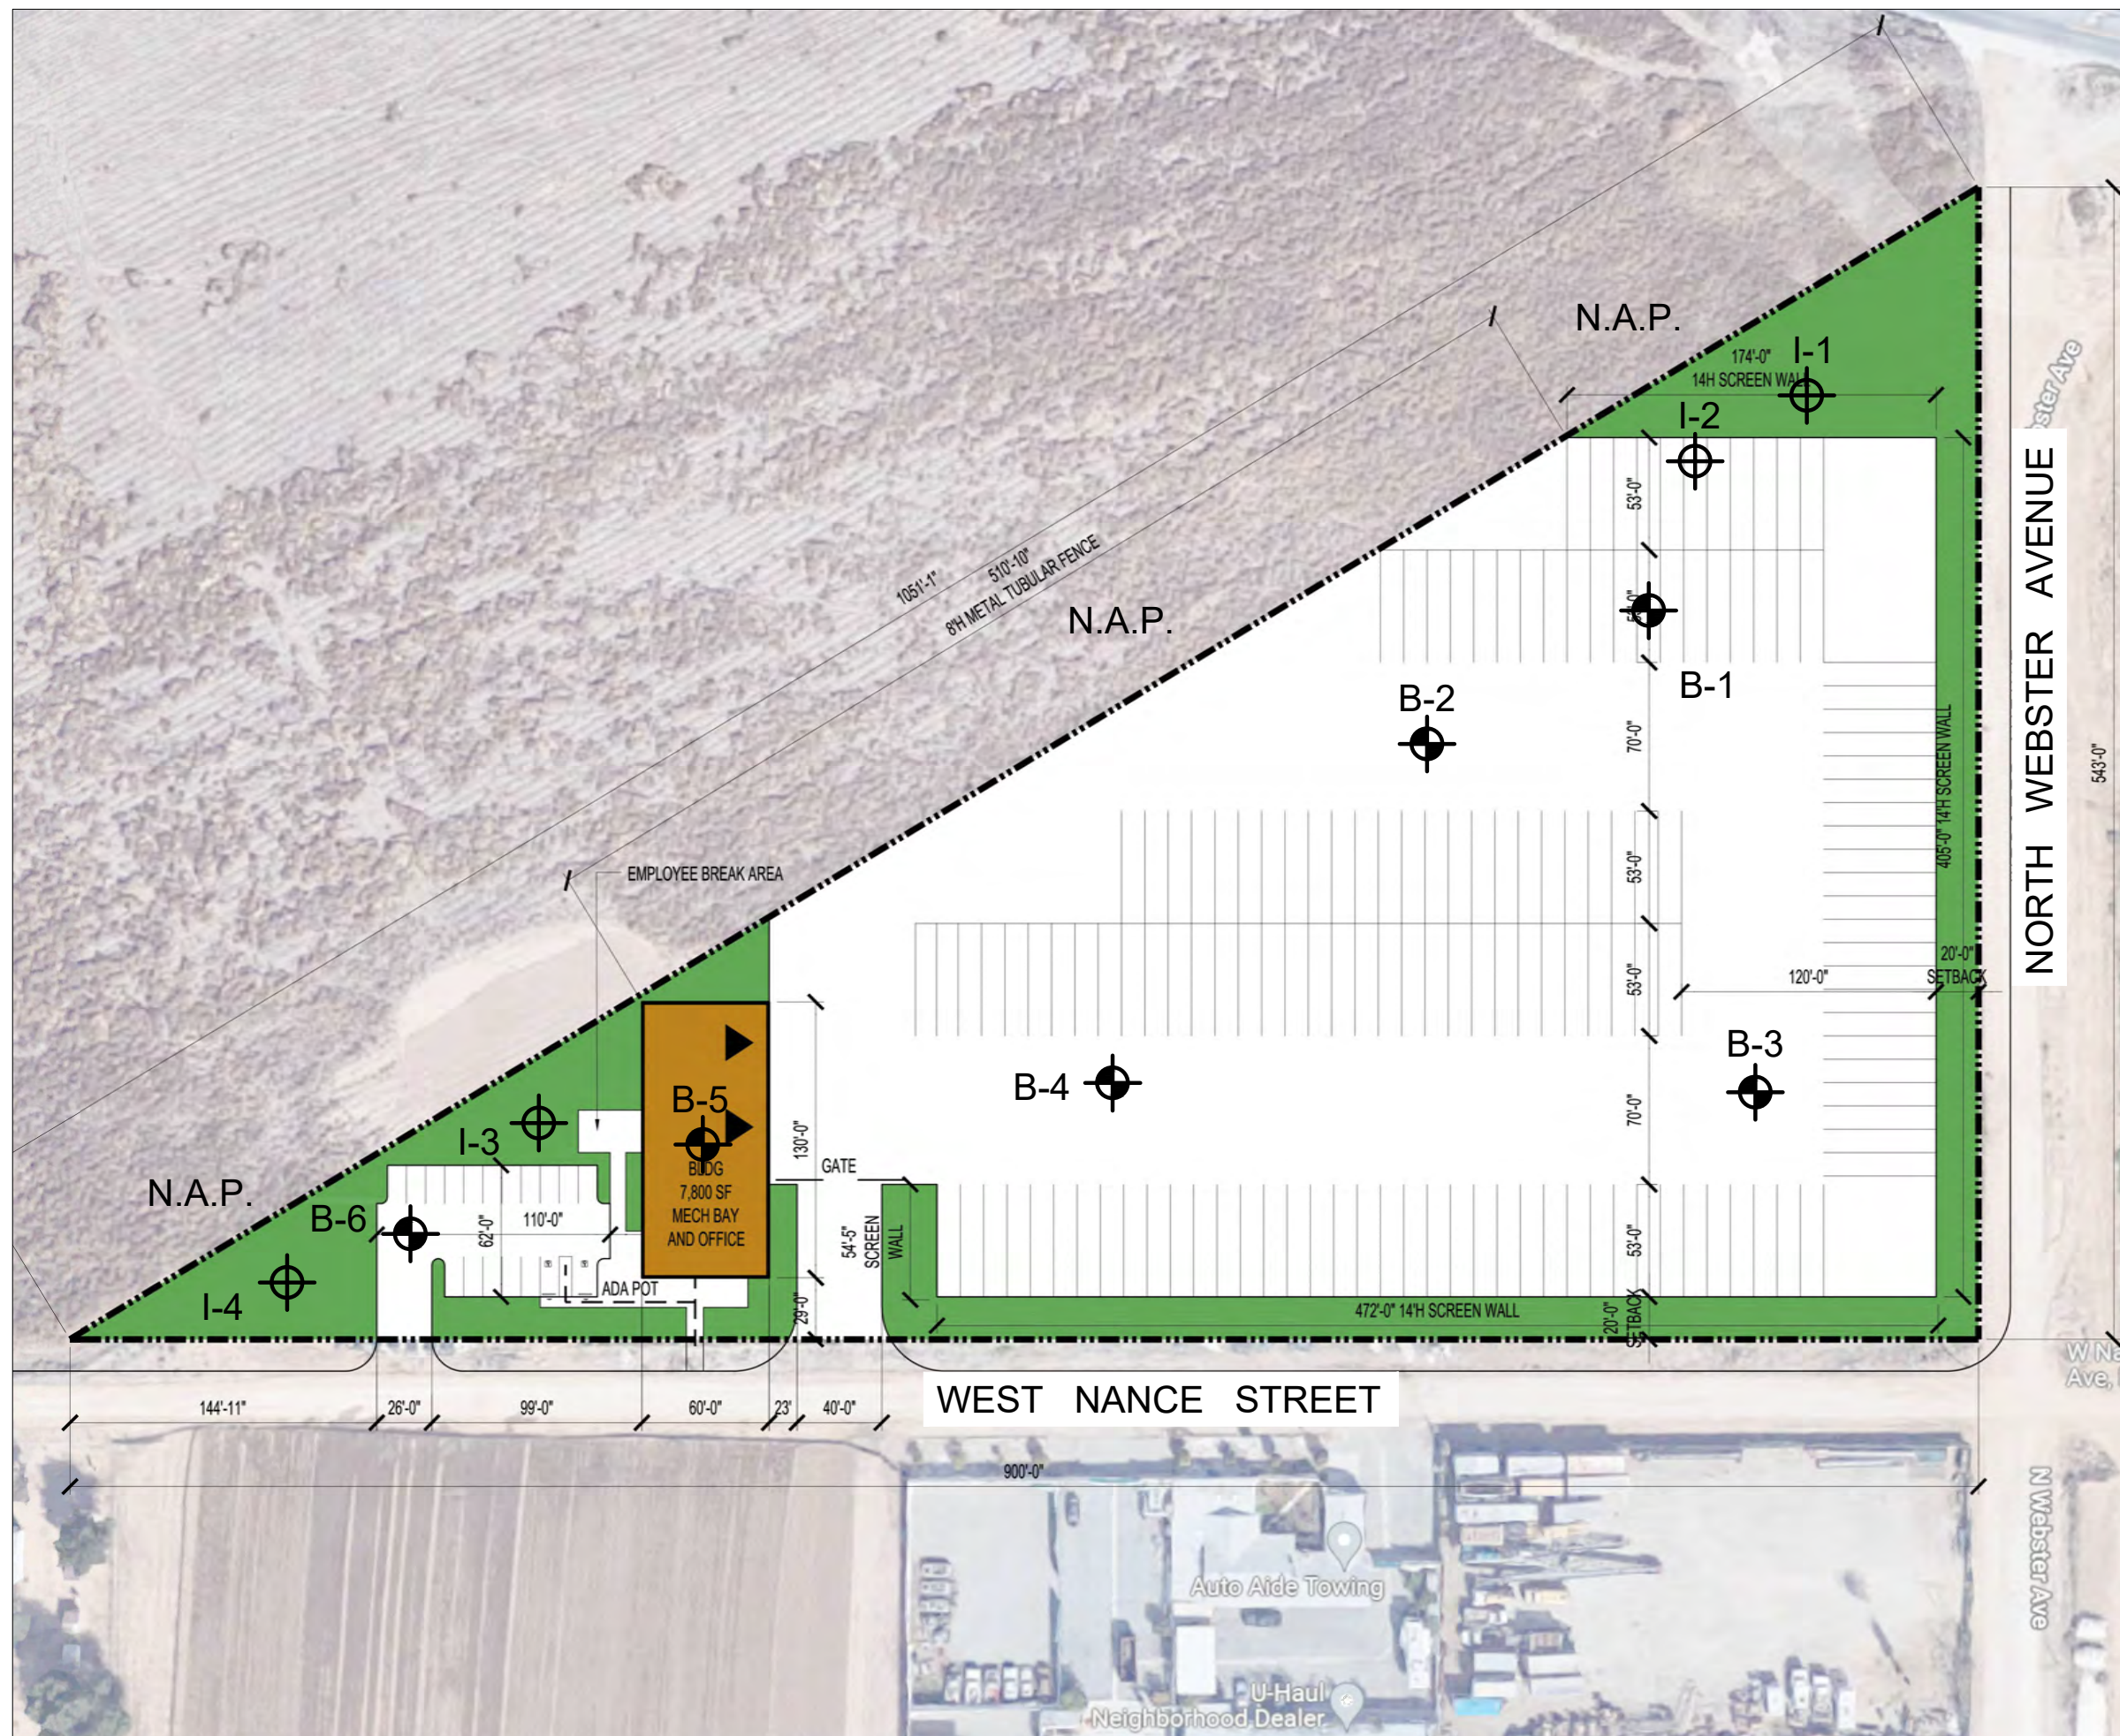
SOUTHERN CALIFORNIA GEOTECHNICAL
DRAWN: JLL	
CHKD: RGT	
SCG PROJECT 22G184-2	
PLATE 1

The site is located at the northwest corner of West Nance Street and North Webster Avenue in Perris, California. The site is bounded to the northwest by a vacant lot, to the south by West Nance Street, and to the east by North Webster Avenue. The general location of the site is illustrated on the Site Location Map, included as Plate 1 of this report.
