Project Specific Preliminary Water Quality  
Management Plan, Perris Industrial Building,  
Nance Street And Nevada Avenue

**PROJECT SPECIFIC PRELIMINARY  
WATER QUALITY MANAGEMENT PLAN  
(P-WQMP)**

**PERRIS INDUSTRIAL BUILDING**  
NANCE STREET AND NEVADA AVENUE  
PERRIS, CALIFORNIA 92571  
APNs: 314-160-013 AND 314-160-014

**THIENES ENGINEERING, INC.**  
14349 FIRESTONE BLVD.  
LA MIRADA, CALIFORNIA 90638  
PHONE: (714) 521-4811  
FAX: (714) 521-4173  
CONTACT: LUIS PRADO (luisp@thieneseng.com)

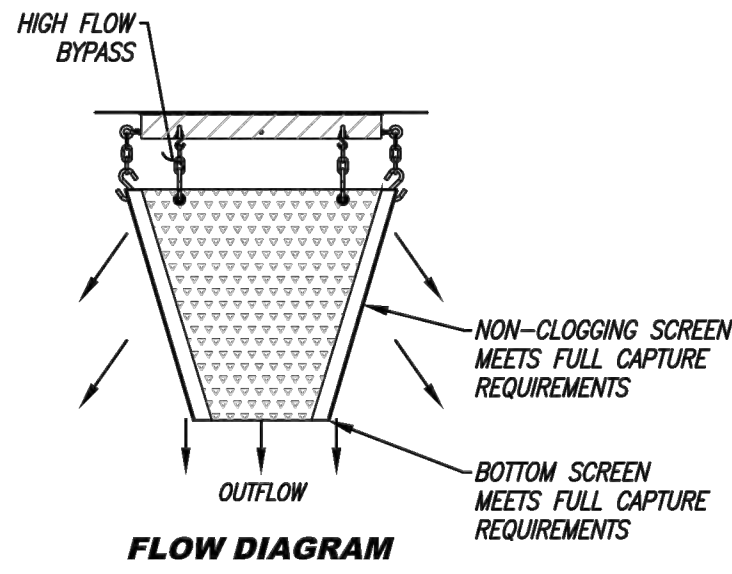
**BIO CLEAN FULL CAPTURE FILTER**  
FOR USE IN GRATE INLETS

MODEL #	TREATMENT FLOW RATE (CFS)	BYPASS FLOW (CFS)	SOLIDS STORAGE CAPACITY (CF)
BIO-GRATE-FULL 12-12-12	1.04	1.24	0.15
BIO-GRATE-FULL 18-18-12	1.78	2.79	0.33
BIO-GRATE-FULL 24-24-12	2.70	4.96	0.59
BIO-GRATE-FULL 24-40-12	3.70	6.35	0.88
BIO-GRATE-FULL 24-24-24	7.31	4.96	1.22
BIO-GRATE-FULL 24-40-24	9.53	6.35	1.82
BIO-GRATE-FULL 36-36-24	11.93	7.74	2.73

2. UNIT MUST BE INSTALLED ON LEVEL BASE. MANUFACTURER RECOMMENDS A MINIMUM 6" LEVEL ROCK BASE UNLESS SPECIFIED BY THE PROJECT ENGINEER. CONTRACTOR IS RESPONSIBLE TO VERIFY PROJECT ENGINEERS RECOMMENDED BASE SPECIFICATIONS.

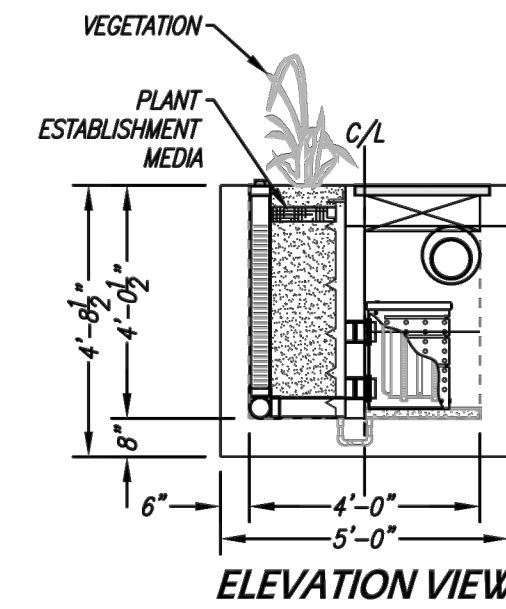
**MWS-L-4-4-V**  
STORMWATER BIOFILTRATION SYSTEM  
STANDARD DETAIL

TREATMENT FLOW (CFS)	0.052
OPERATING HEAD (FT)	3.4
PRETREATMENT LOADING RATE (GPM/SF)	TBD
WETLAND MEDIA LOADING RATE (GPM/SF)	1.0

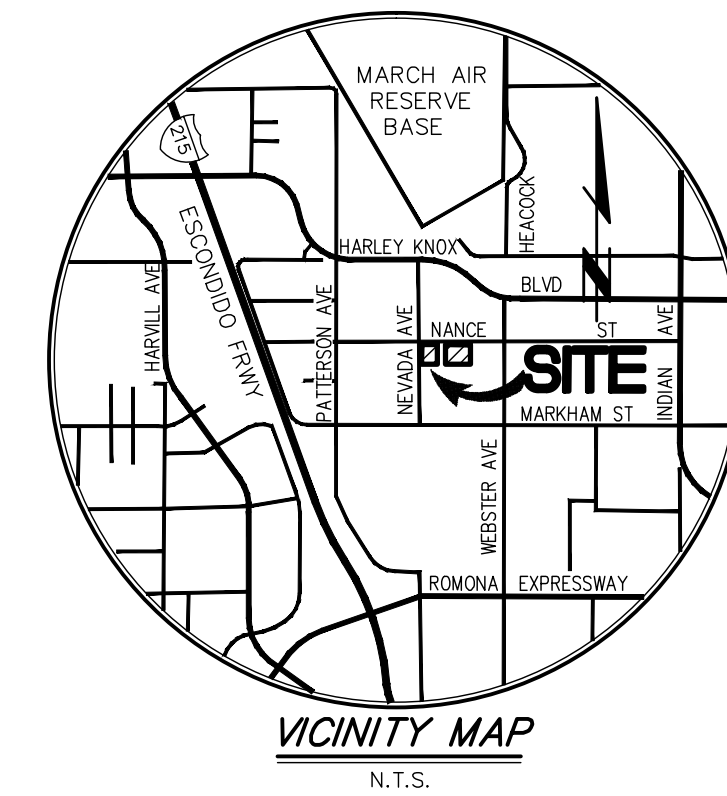
**CITY OF PERRIS**  
PUBLIC WORKS DEPARTMENT  
**CONCEPTUAL STORM DRAIN PLAN**  
PERRIS TRAILER YARD  
NANCE ST. AND NEVADA AVE.

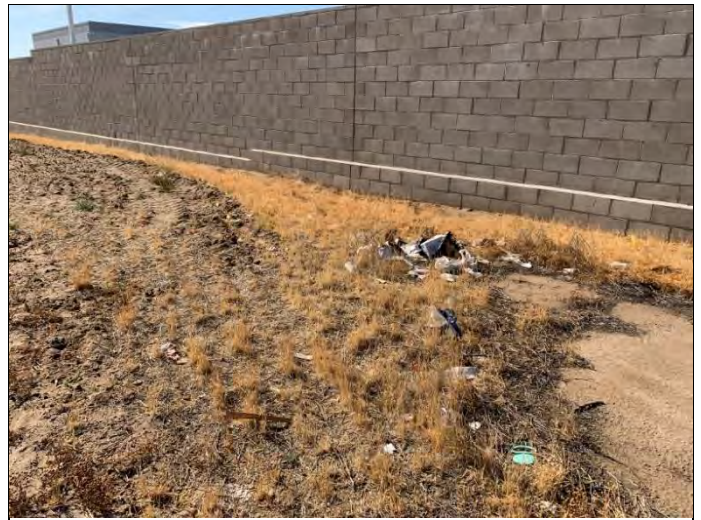
28. Debris on the southwest corner of the site, view facing southeast.

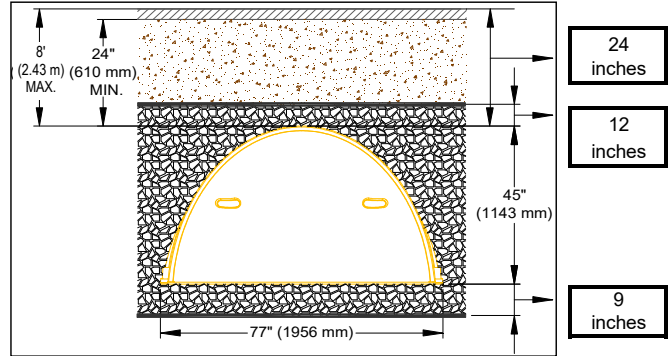
Maximum Width =	20	feet
2 rows of 9 chambers		
Maximum Length =	69.27	feet
Maximum Width =	15.58	feet

Units	Imperial	
Required Storage Volume	3363	CF
Stone Porosity (Industry Standard = 40%)	40	%
Stone Above Chambers (12 inch min.)	12	inches
Stone Foundation Depth (9 inch min.)	9	inches
Average Cover over Chambers (24 inch min.)	24	inches
Bed size controlled by WIDTH or LENGTH?	WIDTH	
Limiting WIDTH or LENGTH dimension	20	feet
Storage Volume per Chamber	178.9	CF
Storage Volume per End Cap	46.9	CF
