(Site 3 - South Nance East)
Project Specific Preliminary Water Quality
Management Plan,
Perris Trailer Yard Nance Street

Thienes Engineering, Inc.
February 23, 2023

**PROJECT SPECIFIC PRELIMINARY
WATER QUALITY MANAGEMENT PLAN
(P-WQMP)**

FOR:
P23-XXXXX
PERRIS TRAILER YARD
NANCE STREET
PERRIS, CALIFORNIA 92571
APNs: 314-160-016, 314-160-017 AND 314-160-018

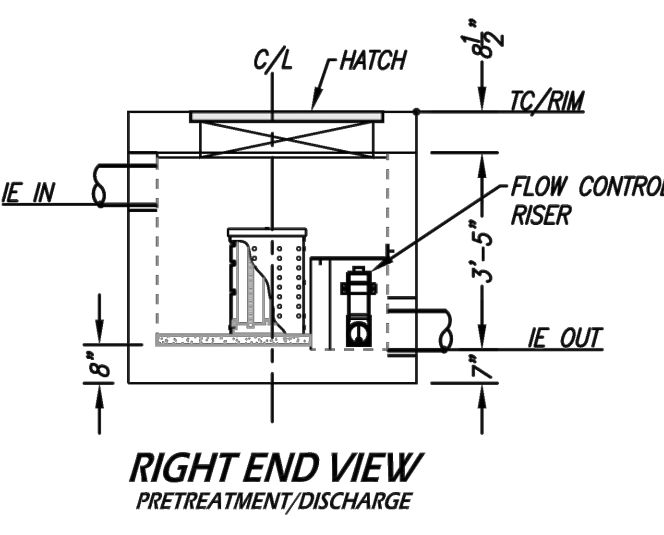
**MWS-L-4-8-V
STORMWATER BIOFILTRATION SYSTEM
STANDARD DETAIL**

TREATMENT FLOW (CFS)	0.115
OPERATING HEAD (FT)	3.4
PRETREATMENT LOADING RATE (GPM/SF)	TBD
WETLAND MEDIA LOADING RATE (GPM/SF)	1.0
